How to Fix a Sagging Lagun Table Mount

John Tauxe, Los Alamos, NM

This documents the process and required materials for fixing the problem of sagging Lagun tables. The mounts for your own tabletop are sold for use on boats and recreational vehicles, and are very useful indeed. But the plastic bearings that the tables are made with inevitably wear, at which point your tabletop has no chance of resting level. There are plenty of videos out there showing how people have attempted to deal with the problem, but I humbly submit that this is the most effective method.

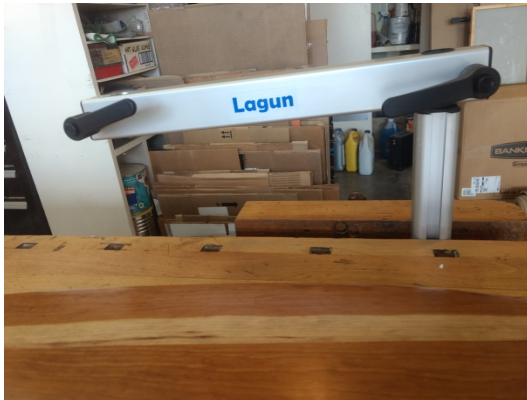
Here's the basic problem. Once the plastic bearings wear, the arm supporting the table (table not shown here) begins to sag. The table will always tilt.

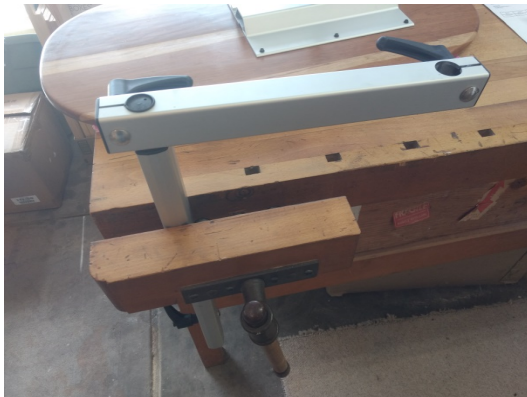
The root cause is the plastic bearings at each end of the arm, shown here. Each bearing assembly has an inner cylinder and an outer ring.

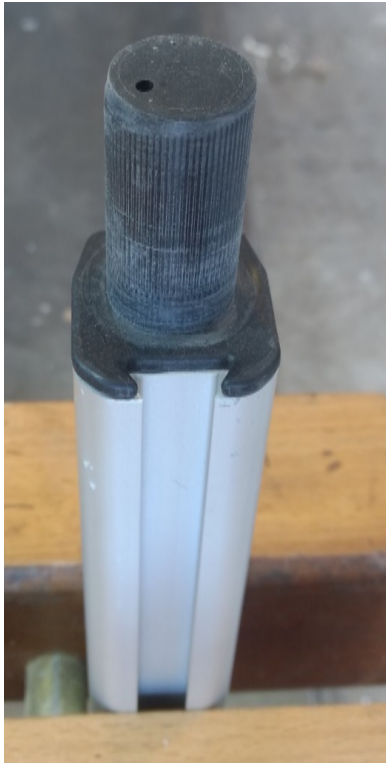
Removing the arm from the post reveals the inner bearing that is part of a larger piece of plastic that is press fitted into the post. Do not remove this.

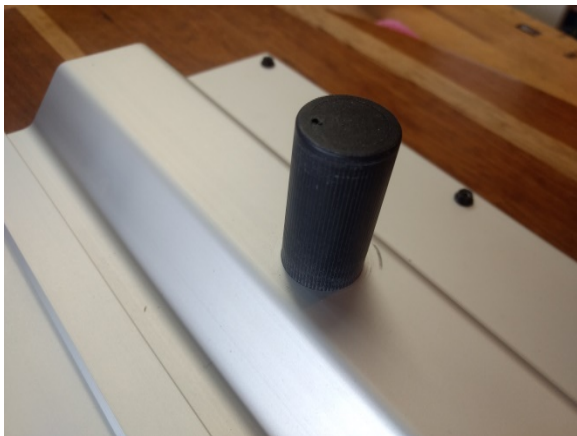
A similar inner bearing is integrated into the table mount. Do not remove this, either.

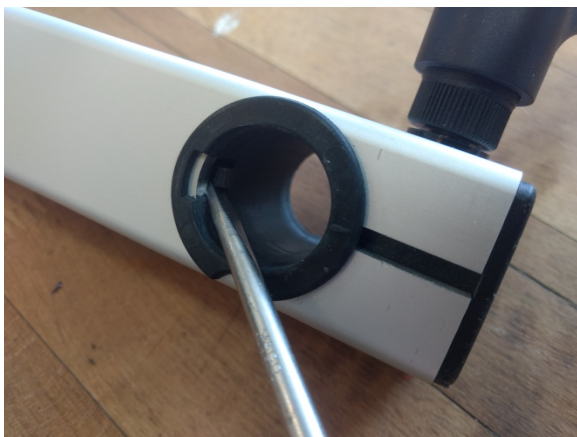
The plastic sleeves that are fitted into each end of the arm do need to be removed, as these will be replaced. Loosen or remove the tightening handle first. A pick or screwdriver helps, and these will be discarded.

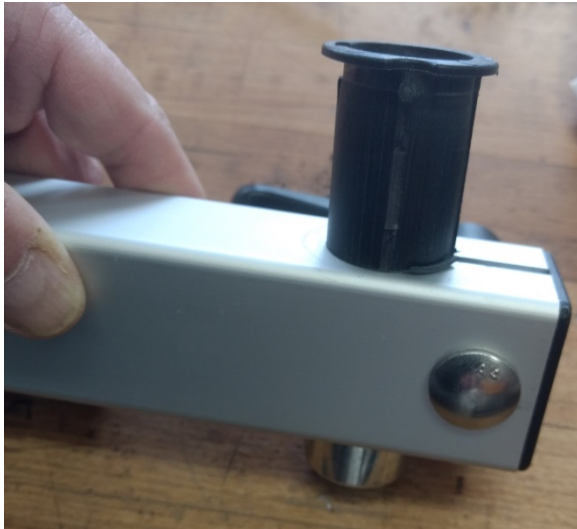
I also used the new bearing sleeves (see below) to help press out the outer plastic sleeve.

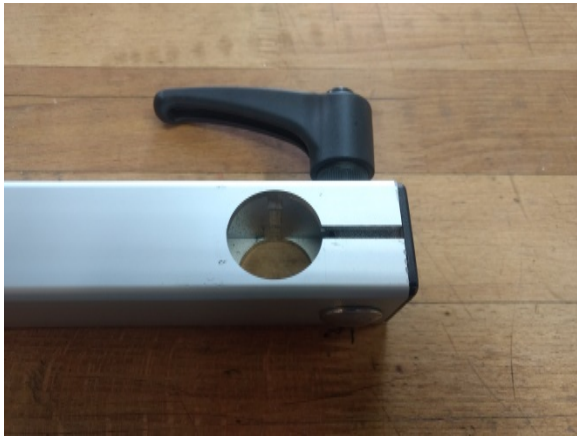
Here the outer sleeve has been removed.

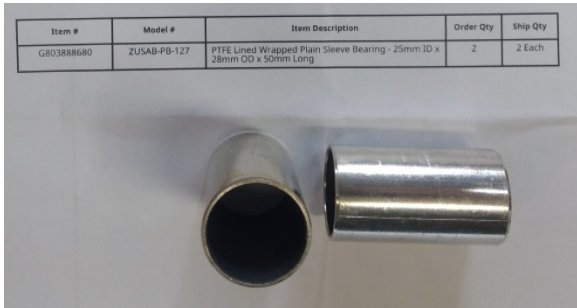
Order these two sleeve bearings beforehand. These are the inner sleeves for the rotating parts. There is no replacement outer sleeve, as the nicely machined arm (pictured above) fits just right around the inner sleeve.

ZUZAB-PB-127
PTFE Lined Wrapped Plain Sleeve Bearing
25 mm ID × 28 mm OD × 50 mm long

I ordered item # G803888680 from Zoro.com.

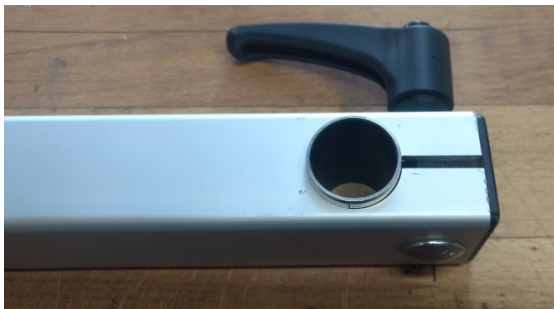
Here is the sleeve temporarily placed in the arm to verify how nicely it fits.

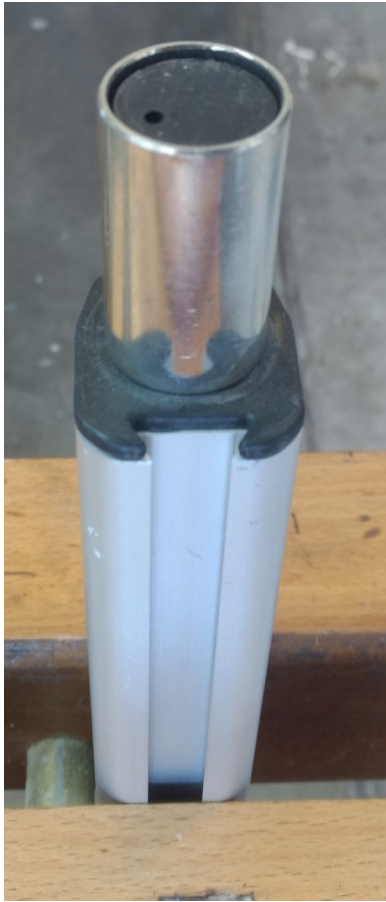
Slip the new metal bearing sleeve over the plastic post. Do the same on the table mount. The next step is to secure this in place, since there is just a bit of slop.

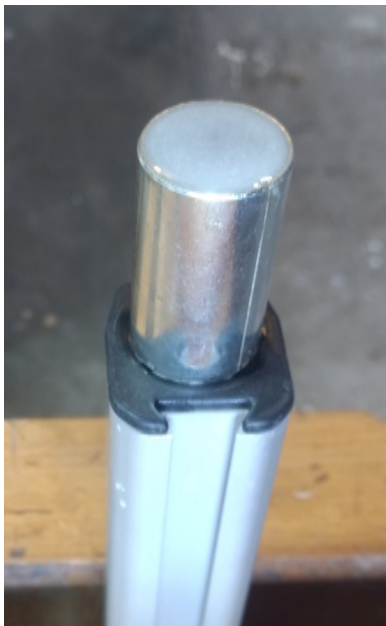
This is the key step. While holding the sleeve up in a half-installed position, mix up some epoxy and pour just a bit onto the post. Work the sleeve down over the post, making sure that the epoxy fills in the empty space around the sleeve. Once the sleeve is all the way down, add enough epoxy to finish the end, covering the plastic. Clean up any spillage.

Do the same for the table mount. Let that set a good long time. I left it overnight.

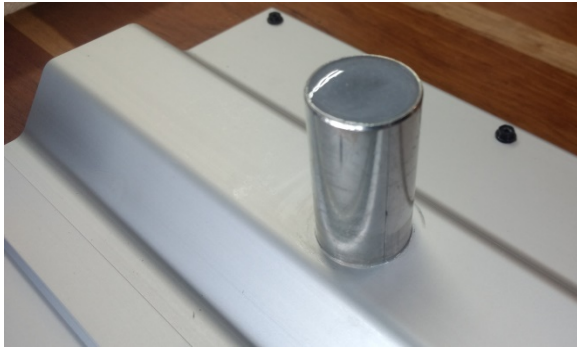
I found that later it became necessary to add a large flat washer screwed into the bottom of the post on the table mount after putting it onto the arm, since even with the epoxy the metal sleeve wanted to move down a bit. The washer is of larger diameter than the metal sleeve, further securing it in place.

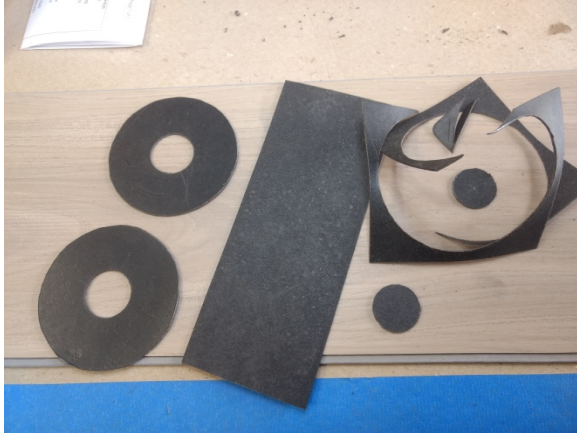
I cut some large “washers” from a heavy plastic report cover sleeve. I used only one of them, between the arm and the table mount. This serves as a low(er) friction surface as the table rotates.

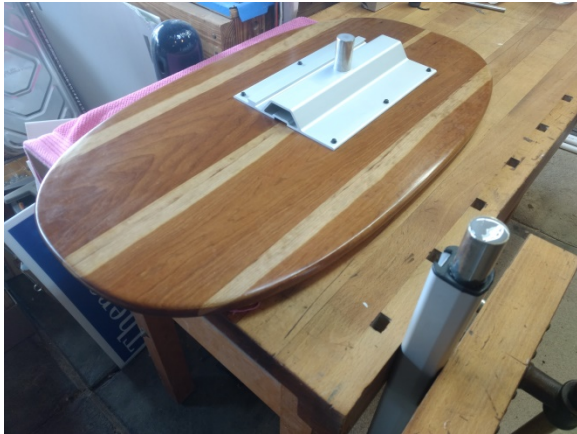
Here is the finished table top and post, ready to reassemble onto the arm.

The table mount is deliberately off center, adding utility in the RV where it lives.
